# Still finding new ACMs after all these years

My concerning find, was as a result of an R&D asbestos survey. The find was above a 3m high suspended ceiling. As an aside, the suspect material only covered approximately 1/8<sup>th</sup> of the ground floor ceiling. Which is a good case in point as to why it is important to inspect ceiling voids in many locations.

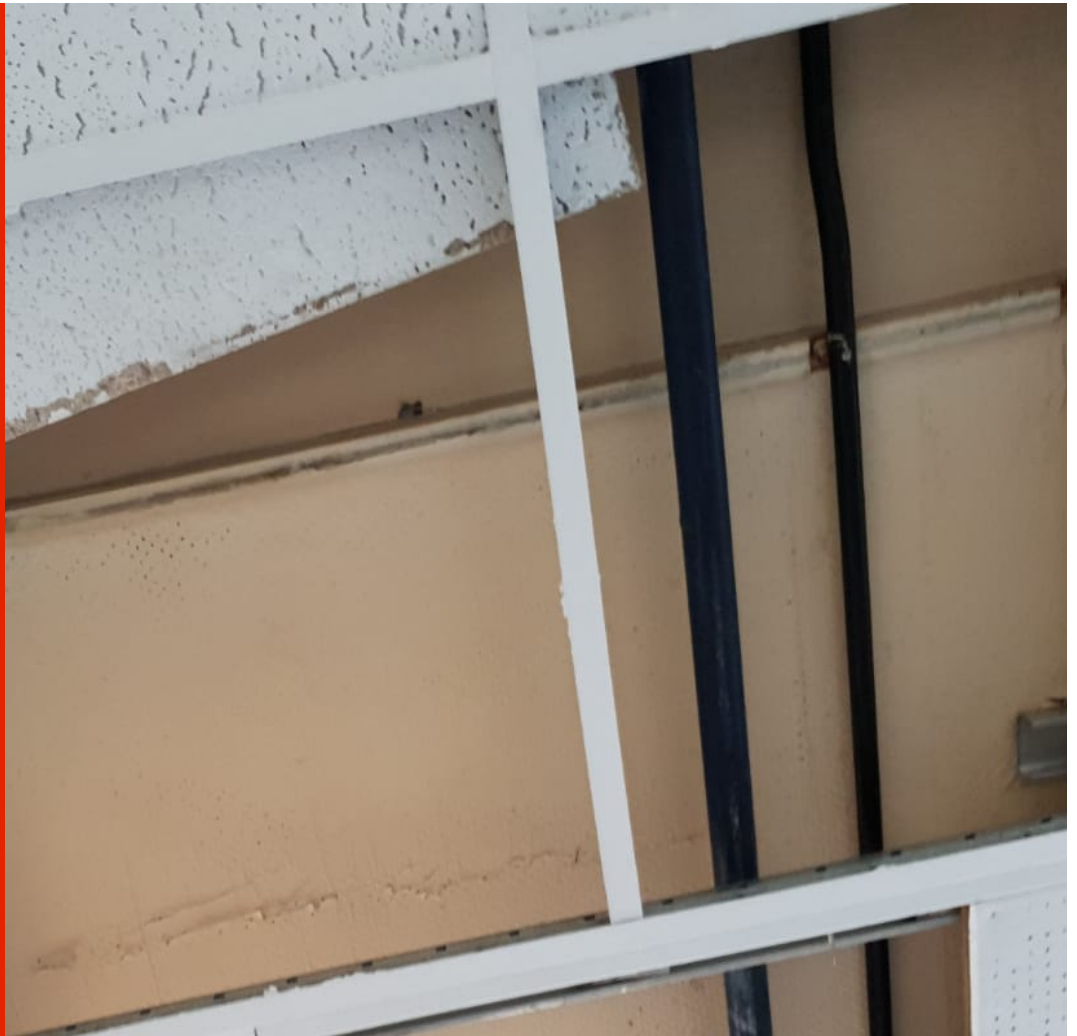
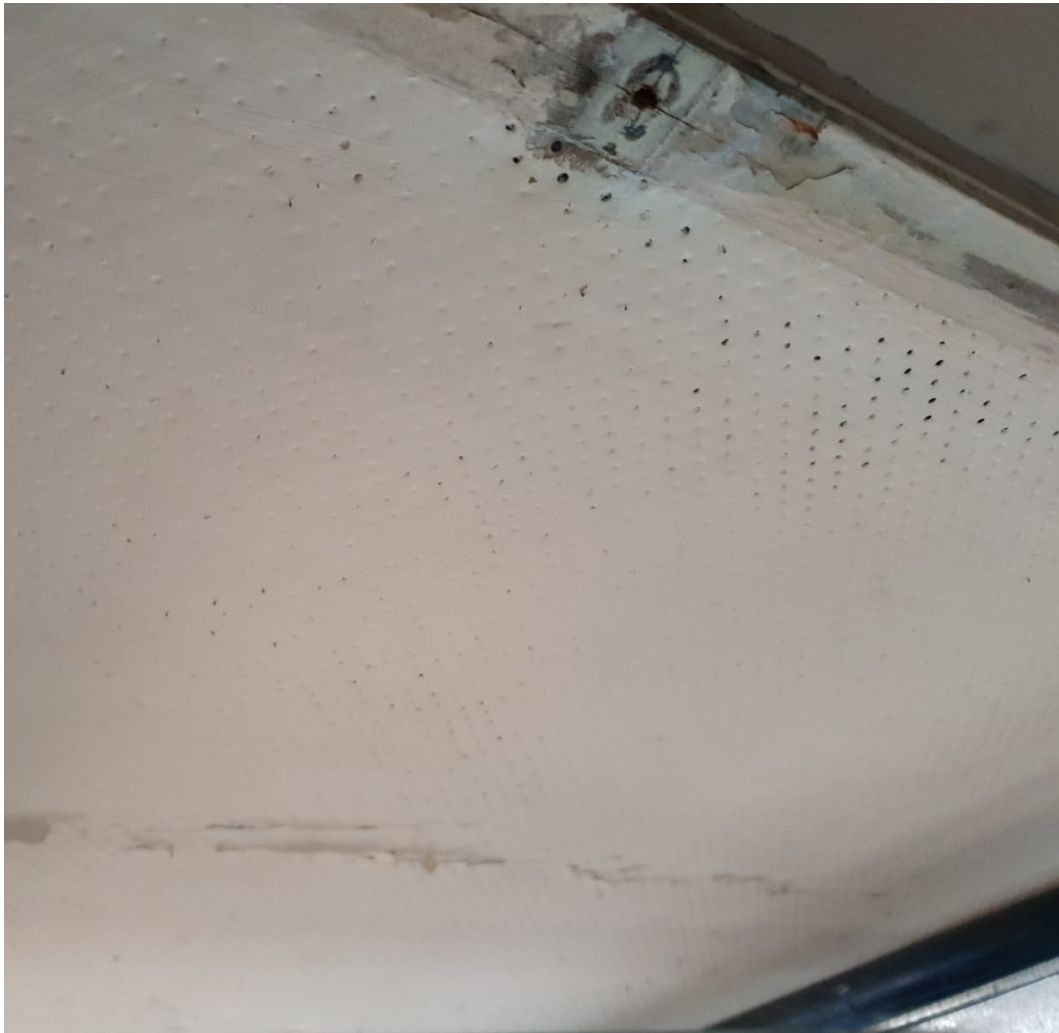
Once located, visually close-up, the material looked like an acoustic tile with a linen/cloth backing. On initial physical inspection, the material had compressed under hand similar to a fiberglass matting, but without the well known fibre crushing sound.

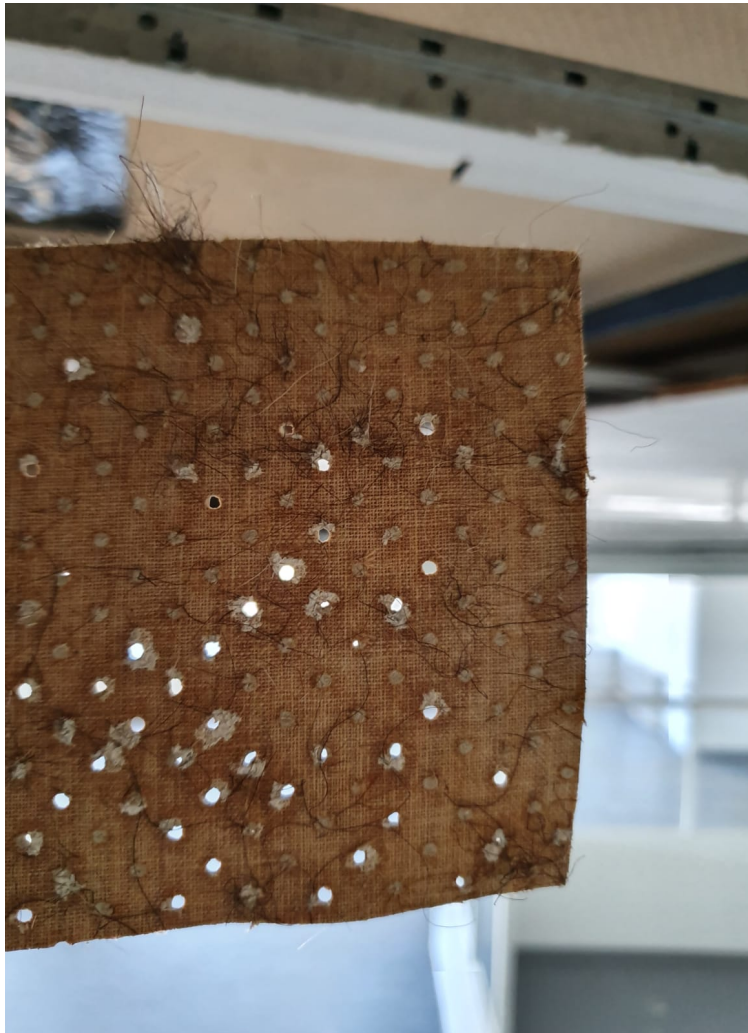
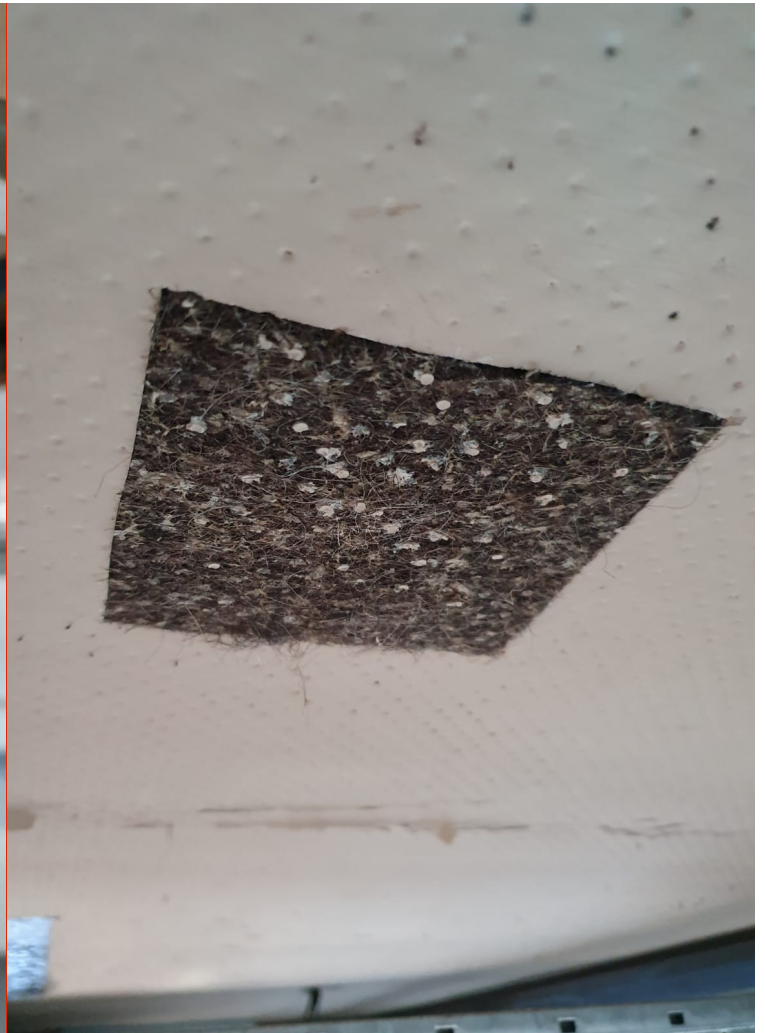
#### **Above Left**

Linnen/Cloth backing approximately 10cm x 10cm cut and carefully removed.

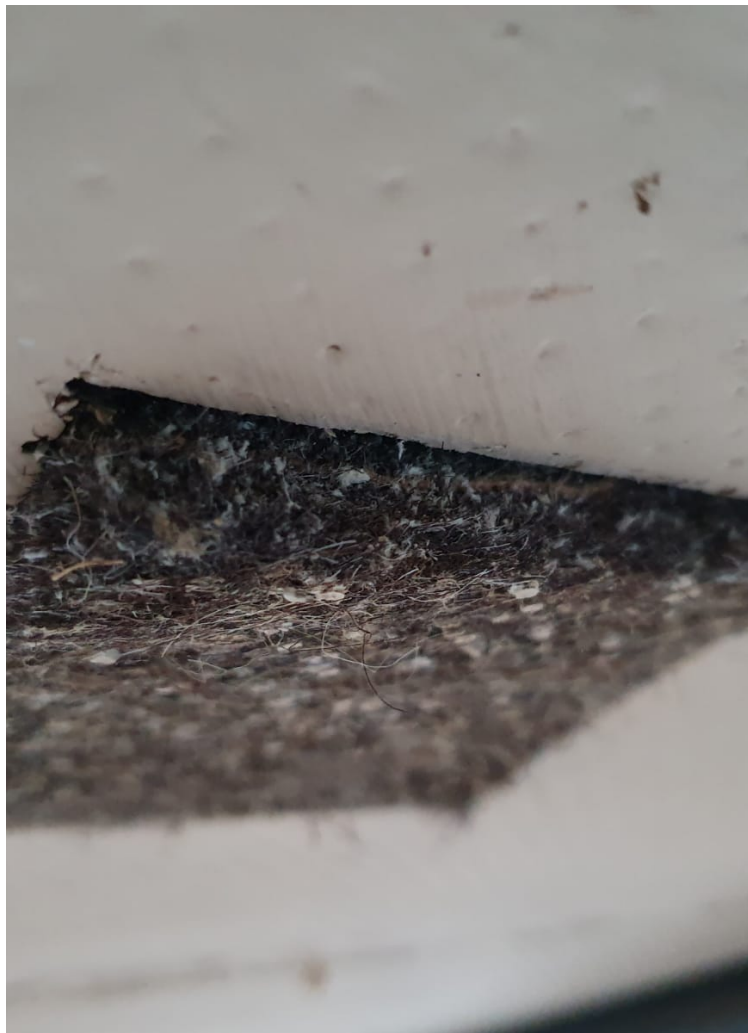
#### **Above Right**

Visually the material looked like an acoustic matting, similar to that found around vehicle engine compartments and under car carpets. Initially thinking that the material could be backed with Chrysotile paper, similar to the medium density fibreboard ceiling tiles, a full thickness cut was made through the material.

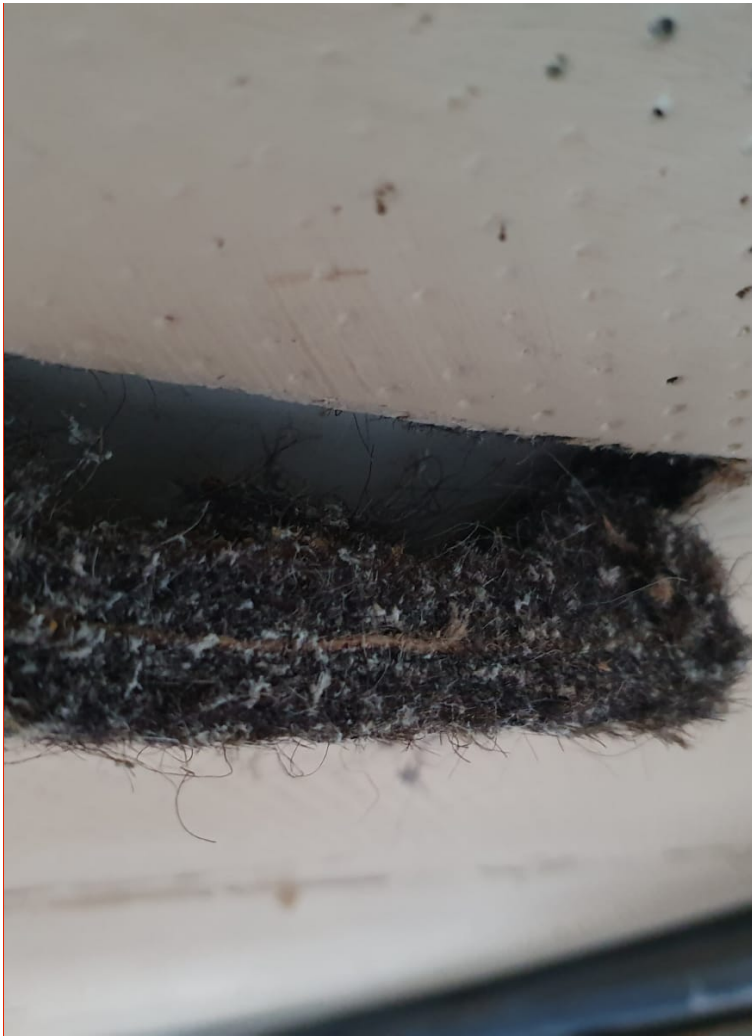
**Above**

Painted back surface, it was not clear from this sample point how the material was attached to the ceiling.

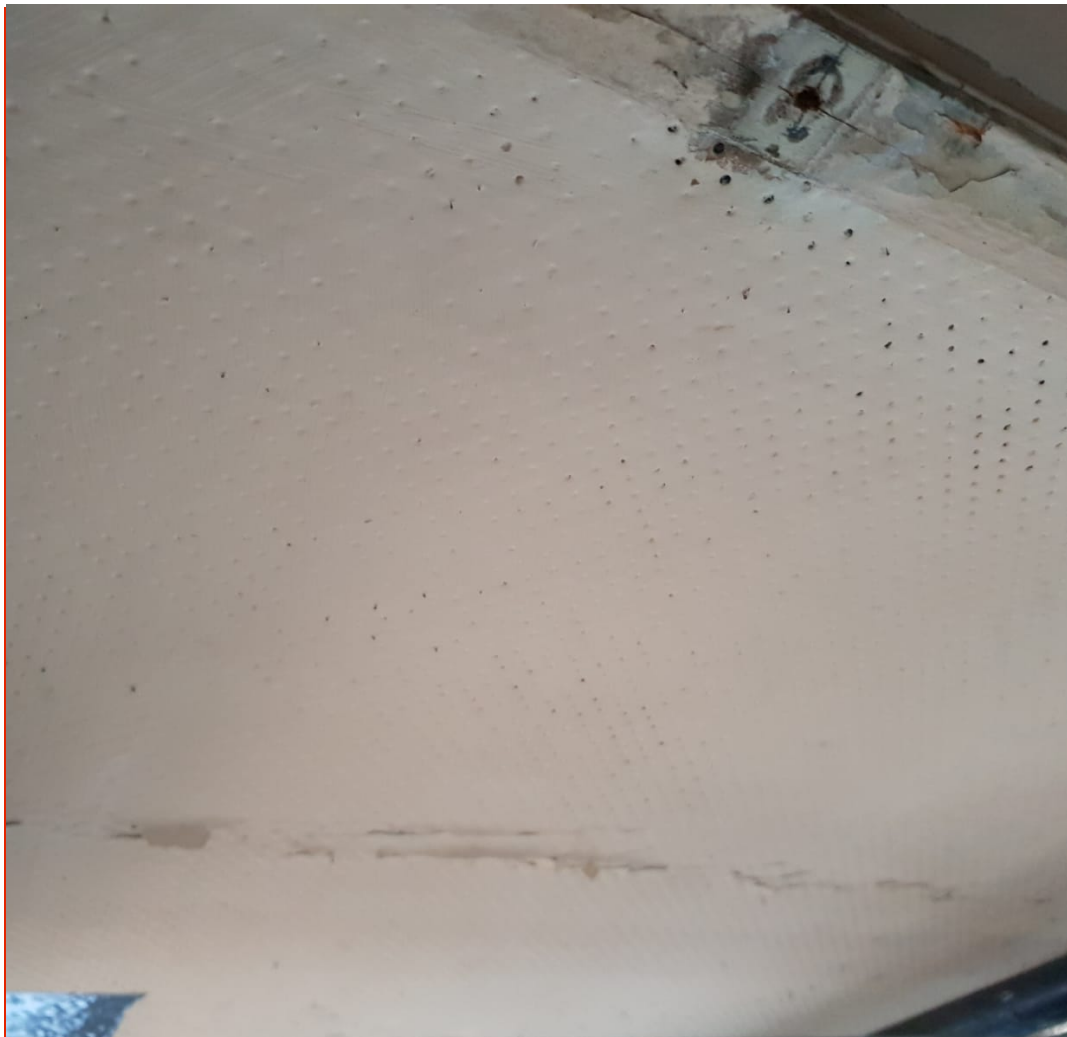
**Left**

The edges are held in place with a metal trim. The material was very light, one suggestion is that it is thought to be held to the structural ceiling with double sided adhesive tape in a grid pattern.

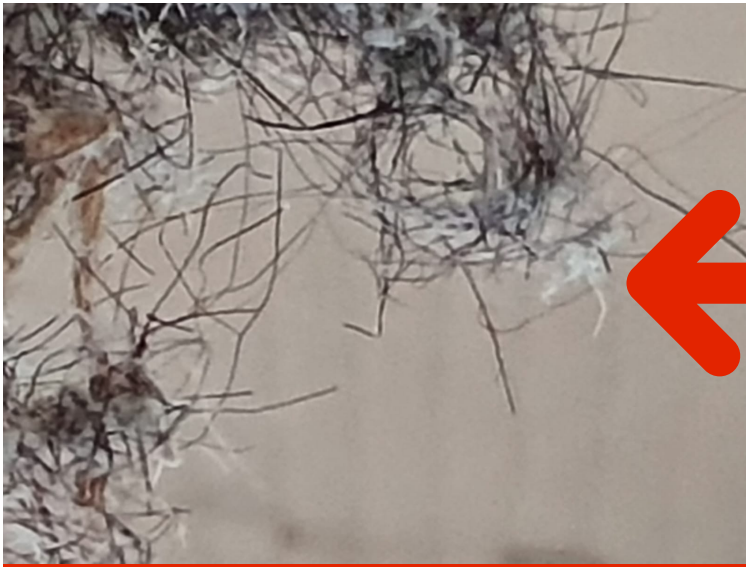
Clump of Chrysotile fibres indicated with the arrow.

Not all white fibres were Chrysotile, it is approximated to be less than 1% asbestos. Other white fibres were similar to the organic fibres found in supalux.

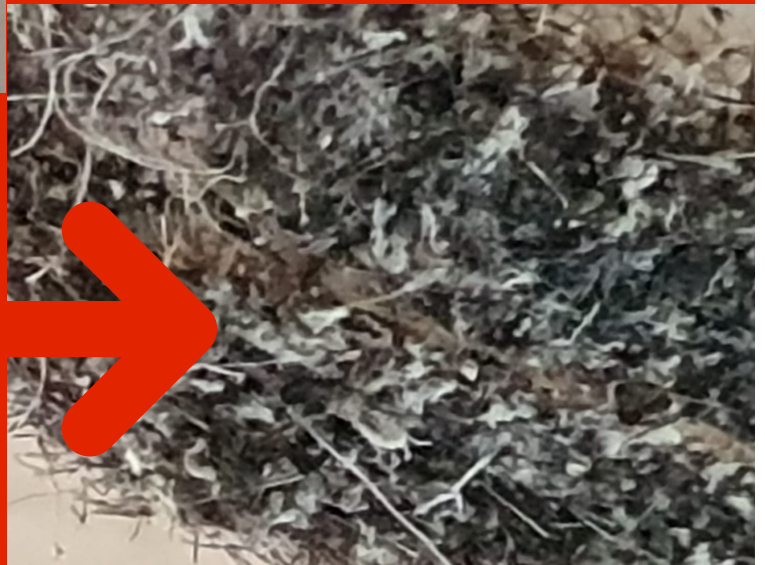
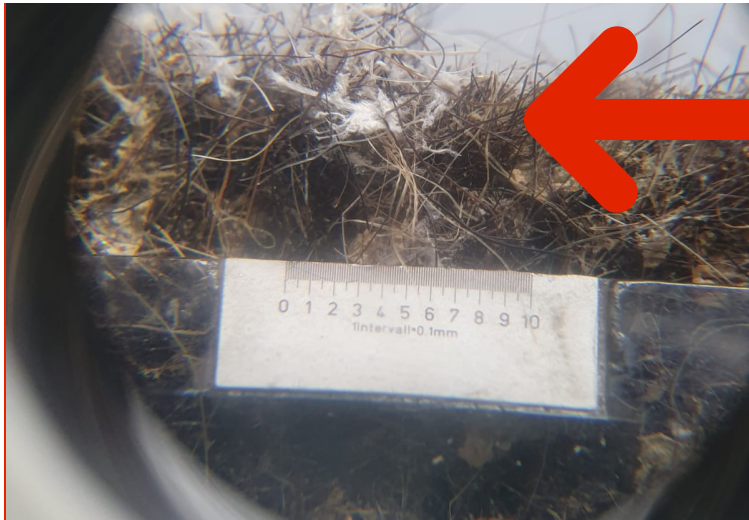
Under 8x magnification the Chrysotile fibres are more obvious.

8x magnification  
1cm scale at 0.1mm intervals,  
i.e between 0 and 1 is 1mm
